**Degradation of Peel and Tensile
Strength of Bonded Panels
Exposed to High Humidity**

DSTO-TR-1272

**Airframes and Engines Division
Aeronautical and Maritime Research Laboratory**

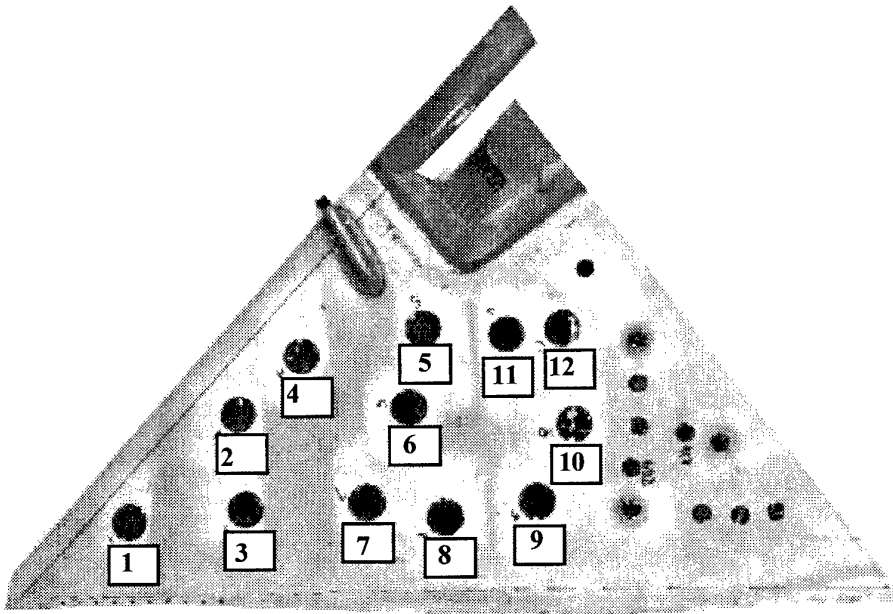
Figure 23 indicates the locations of tensile strength measurements taken on a retired Horizontal Stabiliser Tip (Stab-Tip) from Amberley Air Base. The values for the tensile strength measurements acquired using the portable adhesion tester, refer section 2.2, are provided in Table 2. The average tensile strength value is 590 psi with a standard deviation of 100psi. All the samples either failed as a result of core fracture or cohesive fillet bond failure or a combination of both of these failure modes. The honeycomb had a cell size was 0.25" and the foil gauge was 3.4pcf. Typically, the core fracture is seen for honeycomb with these dimensions and the values around 600psi are acceptable values for undegraded honeycomb structure

Figure 23 Locations of tensile test measurements taken from the Stab-Tip, prior to conditioning.

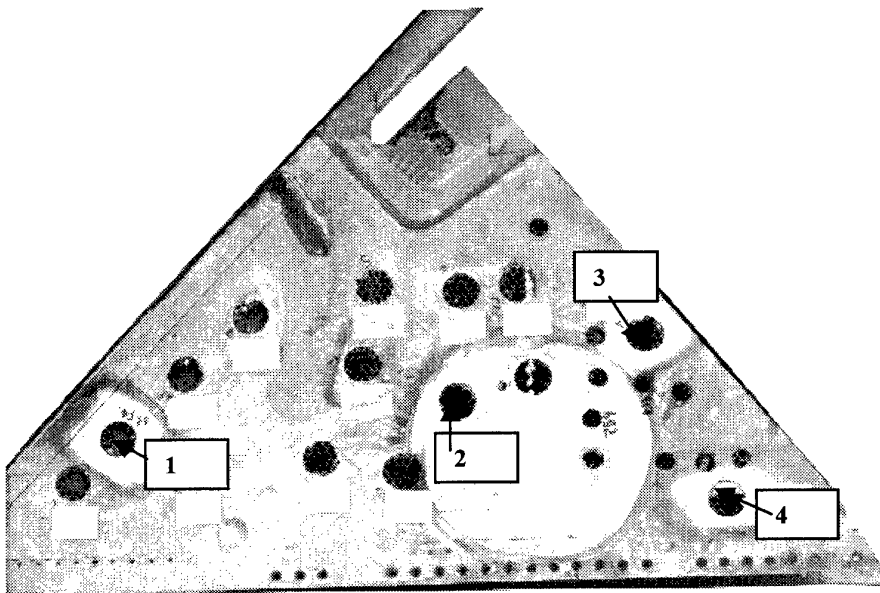
Table 2 also indicates tensile values for samples taken from the Stab-Tip after 20 days and 13 months of immersion in 50°C water. The location of the tensile test measurements are provided in Figure 24 to Figure 26. The data suggests that after 20 days little effect in bond strength results, although a low value of 320psi was recorded for a cohesive failure of the fillet bond adhesive. A similar value and failure mode was observed for a test taken after the Stab-Tip was immersed for 13 months in the 50°C water. It is not clear whether this strength reduction is due to adhesive degradation or not. After 13 months of immersion the Stab-Tip indicated two samples with low values between 200-300psi that failed as a result of core corrosion. Two samples that indicated the onset of fillet bond pull-out did not indicate significant decreases in bond strength. This data suggests that an important factor that may lead to degradation of panel mechanical properties will be due to core corrosion. There is also some suggestion that fillet bond pull-out may occur for extended exposure of bonded panels to humid conditions. Failure surface images of core fracture, core corrosion and fillet bond pull-out are shown in Figure 27 to Figure 29. Generally, the results from the Stab-Tip immersion experiments suggest that in cases of well sealed panels, moisture diffusion into the panel is very slow.

Figure 24 Locations of tensile Test measurements taken from the Stab-Tip after conditioning in 50°C ionised water for 20 days.

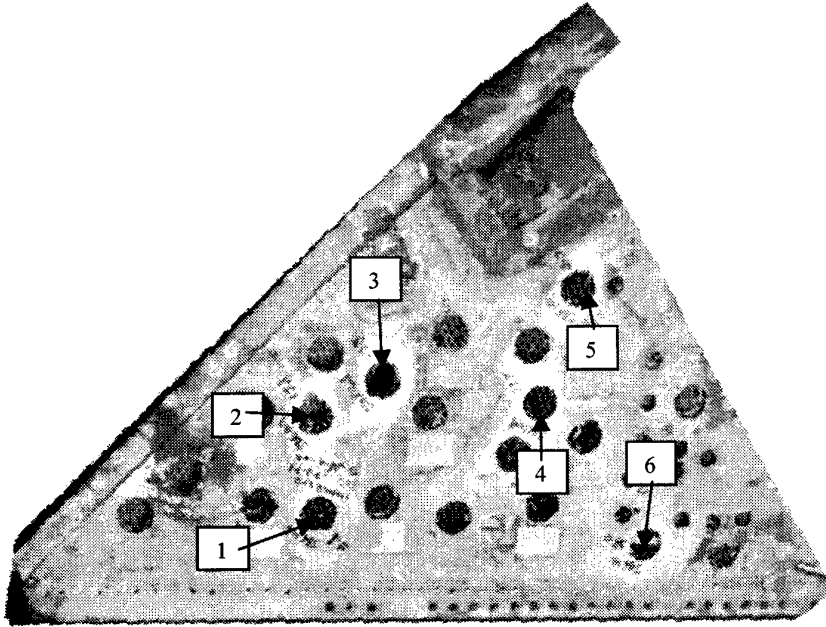
Figure 25 Locations of tensile test measurements taken from side 1 of the Stab-Tip after conditioning for 13 months in 50°C ionised water.

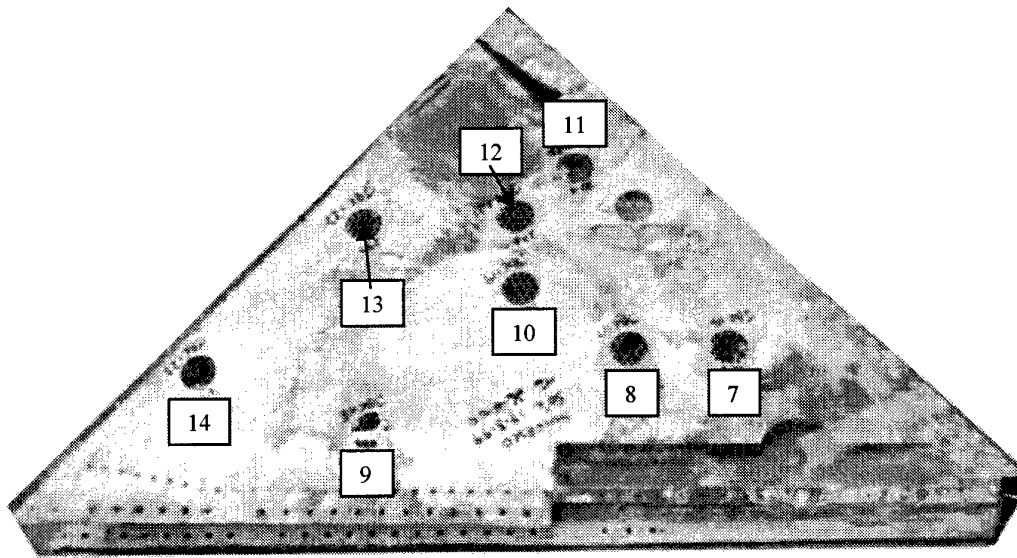
Figure 26 Locations of tensile test measurements taken from side 2 of the Stab-Tip after conditioning for 13 months in 50°C ionised water.

number of holes in the panel being present. In one location moisture ingress into the core had led to corrosion and consequent failure during tensile loading. However, in the majority of cases a mixture of cohesive fillet bond fracture and core fracture was observed. This mode is typically observed for the lighter gauge core material used to fabricate the Stab-Tip panel.

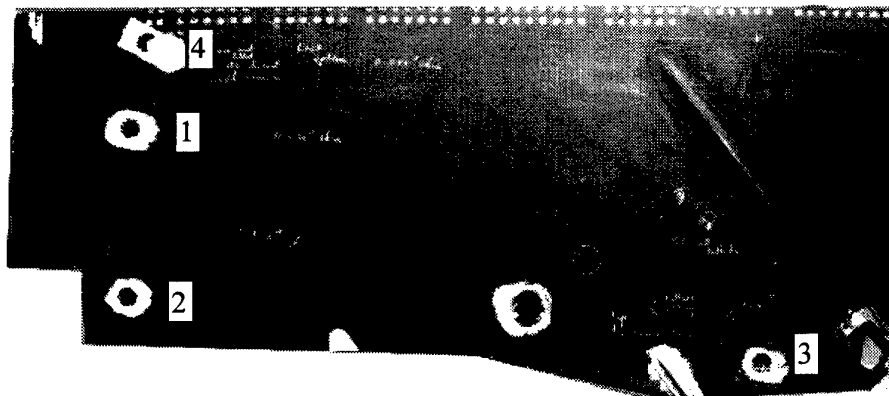
Table 3 indicates the tensile strength of a number of locations on the Starboard Horizontal Stabilizer Tip Cap (Stab-Tip Cap), refer to Figure 30. Two regions that had NDI indications showed notable decrease in tensile strength. In one area a large amount of corrosion between the skin and core had resulted in a zero strength value, refer Figure 31. In another area, where flexure of the core and skin was identified, the reduction in tensile strength to 200psi had resulted from an unsuccessful injection repair, refer Figure 32. Injection repairs have previously been identified by ASI-SRS[7] as causing panel degradation through moisture ingress and the inability of the process to successfully repair disbanded skin to core and edge-member regions. Corrosion, particularly near perimeter regions of bonded panels, appears to be a process that can lead to significant degradation in panel strength. Core corrosion was identified in the controlled exposure of the Stab-Tip examined in 3.2, and clearly, is something that should be considered for panel inspection. The NDI examination also suggested panel degradation as a result of the Tap Hammer test. The tensile strength in this area was adequate and highlights the difficulties in applying this method to successfully identify panel degradation or damage.

Figure 30 Positions of Elcometer tests taken from Stab-Tip Cap.
